CDF ISL Cooling Update

Peter Wilson

All Experimenters Meeting

July 2, 2007

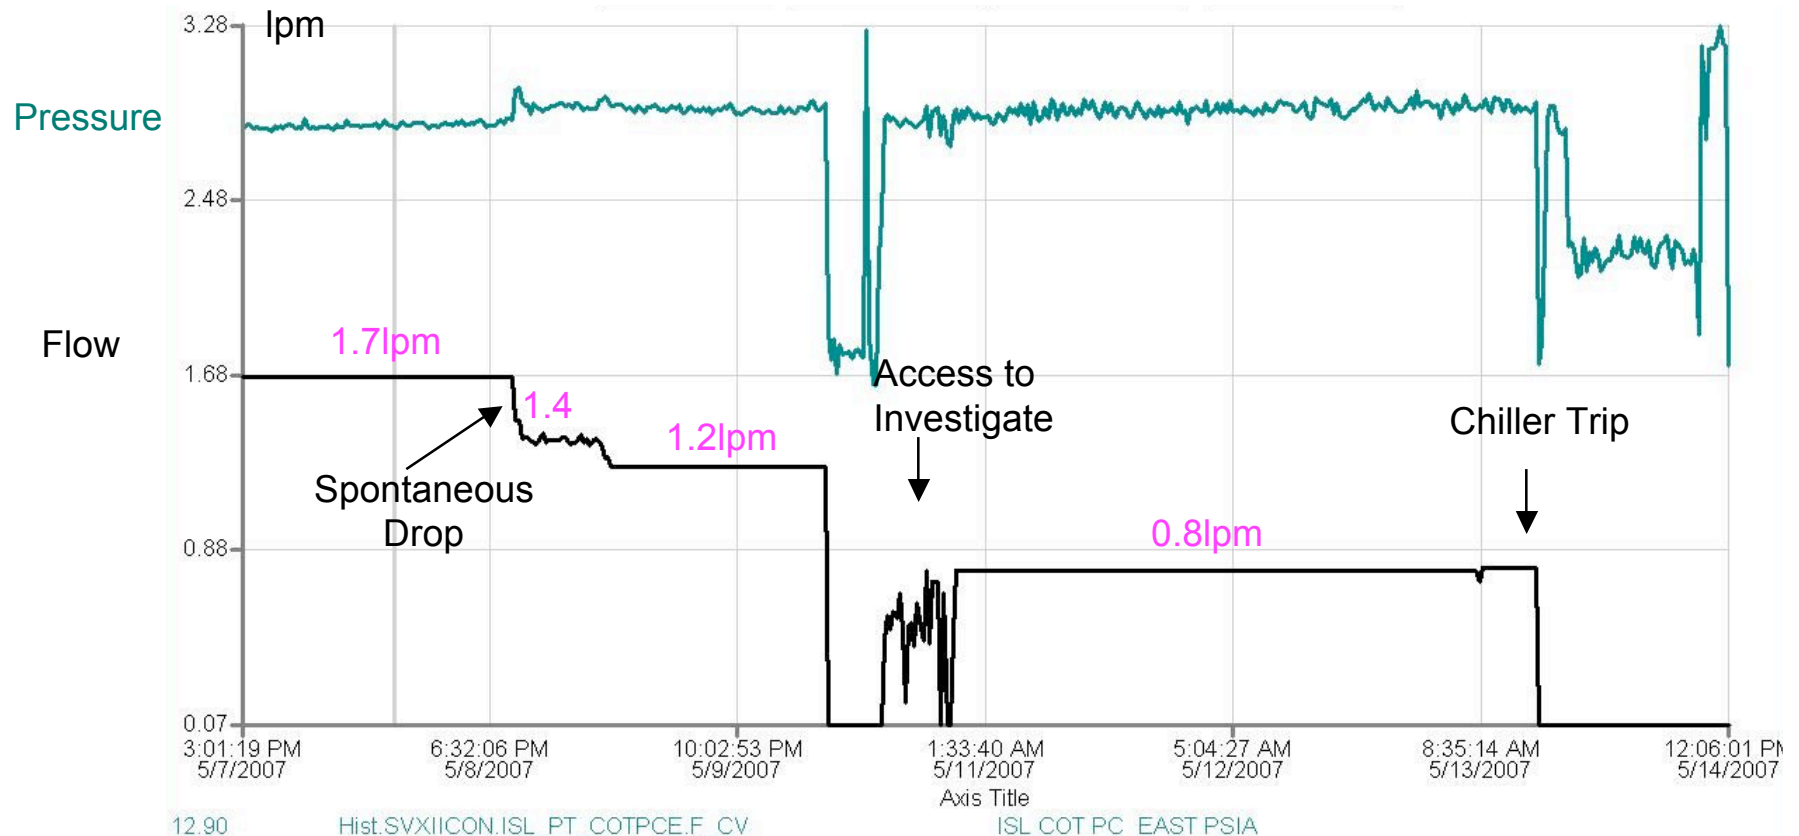
- May 8-13 flow in East ISL/L00 portcard circuit dropped from 1.7 lpm (nominal) to 0.0 lpm:

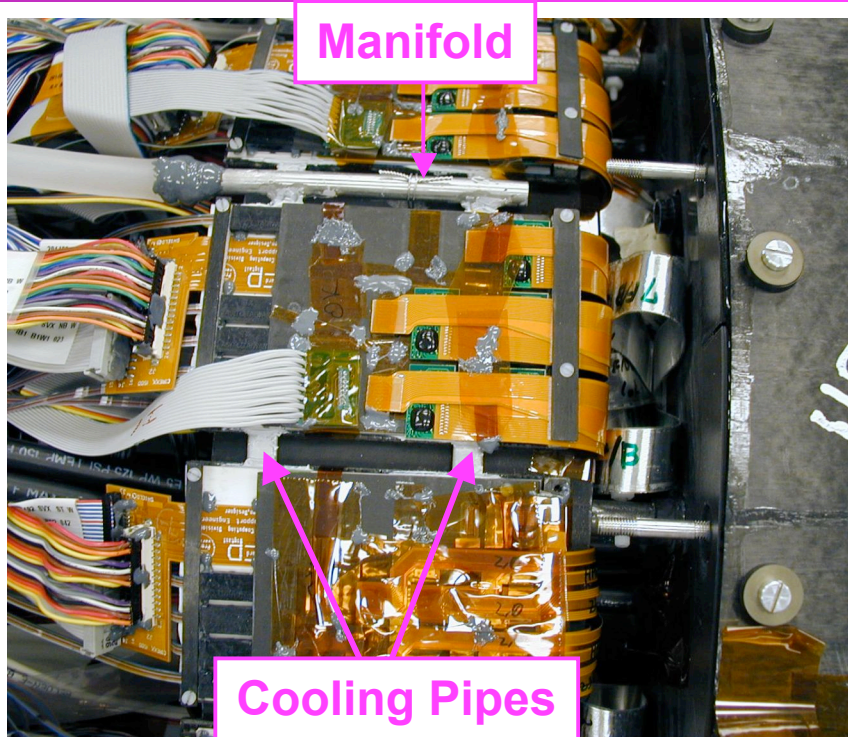
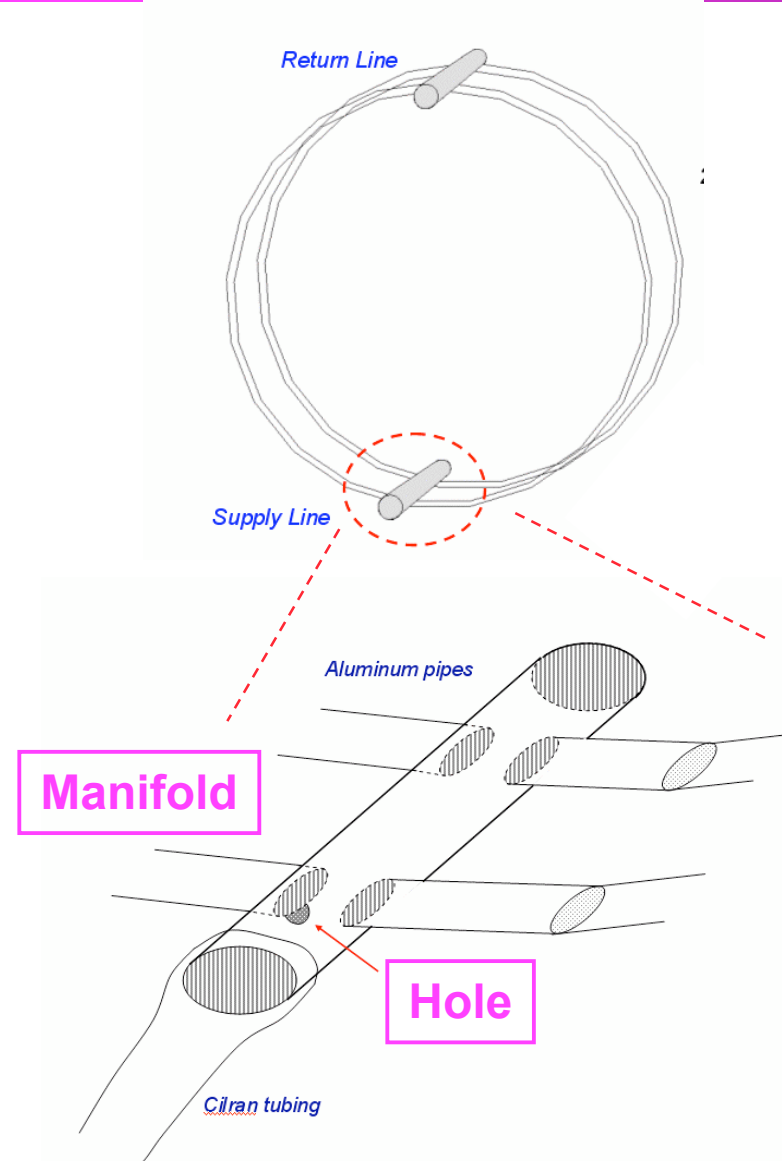
ILS/L00 PortCard Cooling

- Manifold - AL 6061-T6, 30mil wall
- Cooling Rings - AL 5052, 20mil wall
- Welded
- Inner surface area: 0.12m^2

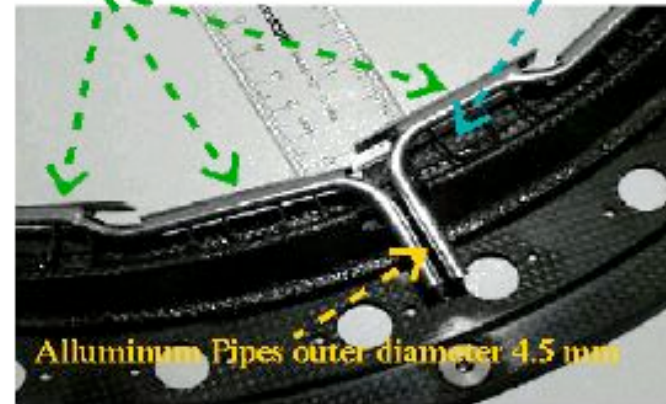
ISL Ladder Cooling

- Aluminum tubes (AL 1100)
 - ID 3.8mm or 4.0mm
 - Wall: 10mils
 - Total tubing: 50m
 - Inner surface area: 0.6m²
- Combined in sets of 4 or 5 via small manifolds
- Joints at manifolds and 90° bends use epoxy
- No welds

Maximum of 9 ladders in one cooling channel
 $\Delta T(\text{IN-OUT}) \sim 1^\circ\text{C}$
